Bath Heritage Watchdog

APPLICATION NUMBER: 17/04265/FUL

ADDRESS: Belvoir Castle, 32-33 Victoria Buildings, Bath

COMMENT: Additional OBJECTION

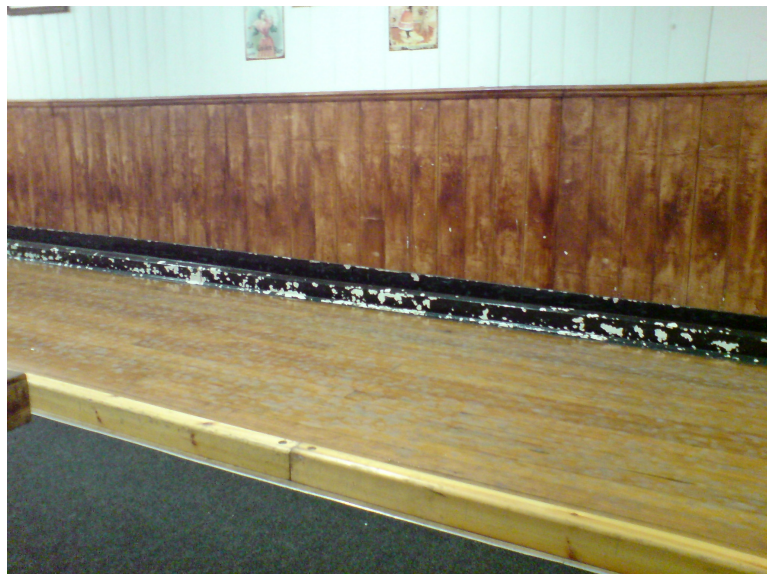
In this first photo, there is a clear “tide mark” which shows the same angle as the slope on the garden and Midland Road. This is evidence of a past flood event, which we had assumed from the flood photos provided in the application but could not prove. This picture is the proof. The second photo is a longer view and is less distinct so we have not used it, but it does show that at the end of the skittle alley (furthest from the Lower Bristol Road) the “tide mark” is just above the panelling dado, which is estimated as 1.2 metres.

There is an important difference between a location that is at risk of future flooding, and a location which already has visible evidence of past flooding to a significant depth.
